# Strengthening Reinforced Concrete Beams Using Fiber Reinforced Polymer (FRP) Laminates

by N. F. Grace, G. A. Sayed, A. K. Soliman and K. R. Saleh

*ACI Structural Journal*, V. 96, No. 5, September-October 1999.

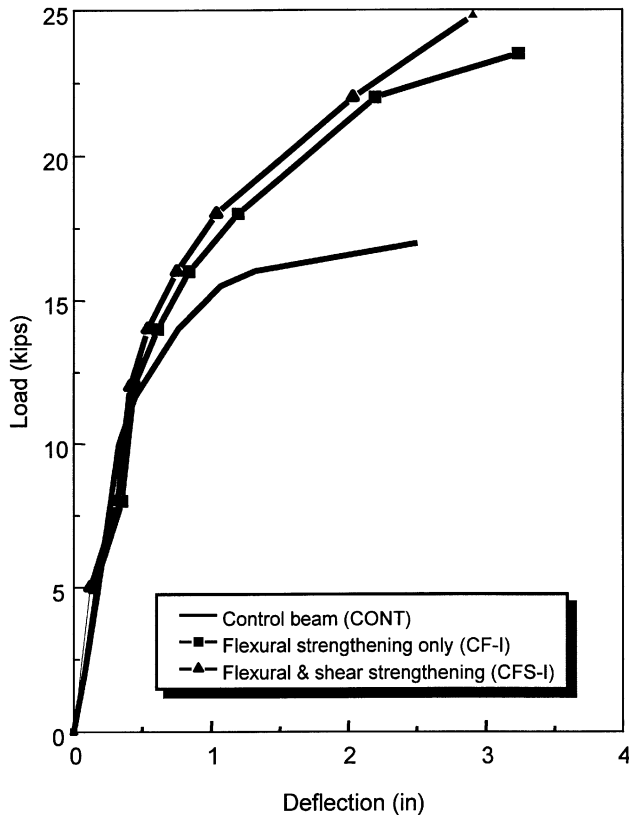
Fig. 2—Response of Group 1 strengthened beams.

In Fig. 2, the load-deflection relationships of the control Beam CONT and the two strengthened Beams CF-I and CFS-I are compared. At a load of 66.7 kN (15 kips), flexural strengthening of Beam CF-I decreased its deflection by 24 percent, while a combination of both flexural and shear strengthening in beam CFS-I decreased its deflection by 48 percent. These large reductions in deflection are noticeable at a high load level (above 70 percent of the load carrying capacity of the beams). This indicates that while strengthening the maximum shear areas does not significantly decrease deflections at service loads, it does reduce deflections by 1/2 at higher load levels. This was expected since the presence of the vertical CFRP sheets at both ends of the beam eliminated the development of diagonal tension cracks.

Table 5 summarizes the maximum loads experienced by the tested beams. Beam UG2-III exhibited the maximum load carrying capacity, which is about 2.35 times that of the control beam. By comparing the load-deflection relationships for Beams CF-I and CFS-I, it is obvious that strengthening the beams with vertical U-shape layers at the ends improved the beams' load-carrying capacity (Fig. 2).

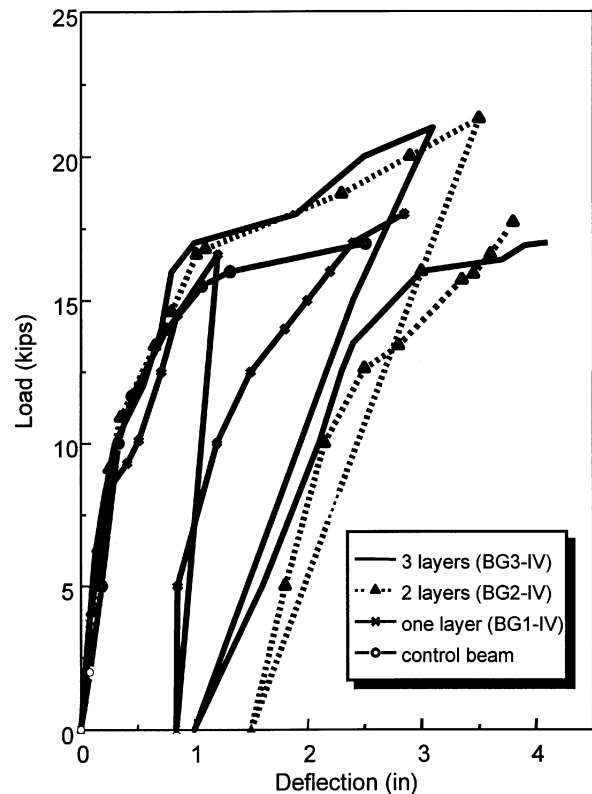
Fig. 4—Response of Group 3 strengthened beams.

Fig. 4 shows the load-deflection relationships of the control beam and the Beams BG1-IV, BG2-IV, and BG3-IV. As shown in Fig. 4 and Table 5, Beams BG1-IV, BG2-IV, and BG3-IV experienced deflections of 72, 96, and 104 mm (2.85, 3.80, and 4.10 in.), respectively. Beam BG1-IV had the lowest deflection of the tested beams. However, at a load of 66.7 kN (15 kips), its deflection was second highest. This can be explained by the low failure load of this beam (only a 6 percent increase over the control beam). The behavior of Beams BG2-IV and BG3-IV was similar, with the exception of their residual deflection. While Beam BG2-IV experienced 38-mm (1.5-in.) residual deflection, Beam BG3-IV experienced only 25-mm (1.-in.). Aside from the effect on residual deflection, no significant effect of the number of layers on deflection was noticed. At the start of delamination

Fig. 4 shows the load-maximum deflection relationships for Beams BG1-IV, BG2-IV, and BG3-IV, as well as the control beam. The beams failed at 80.0, 94.7, 92.5, and 75.2 kN (18.0, 21.3, 20.8, and 16.9 kips), respectively. Using one layer of GFRP increased the failure load from 75.2 kN (16.9 kips) in Beam CONT to 80.0 kN (18.0 kips) in Beam BG1-IV—only a 6 percent increase. Bonding another layer of GFRP onto Beam BG2-IV increased the failure load to 94.7 kN (21.3 kips), a 25.5 percent increase over the control beam and a 18.3 percent increase over Beam BG1-IV. However, adding a third layer of GFRP over the first two layers did not increase the failure load, as shown by the behavior of Beam BG3-IV. Failure of Beam BG1-IV occurred due to the rupture of GFRP sheets, followed by crushing of concrete. Using two layers of GFRP sheets in Beam BG2-IV cut the stresses in GFRP sheets in half and resulted in delamination between the two GFRP sheets and the concrete. Bonding a third layer of GFRP did not change the failure load as the overall load carrying capacity was governed mainly by the epoxy bond strength. In the same way, Beam BG3-IV also experienced a delamination failure similar to that of Beam BG2-IV. Therefore, to exploit the full strength of strengthening sheets, a minimum value of epoxy strength is needed. If the strength of the epoxy is less than this value, the overall load carrying capacity of the beam will be governed by delamination failure rather than sheets rupture.

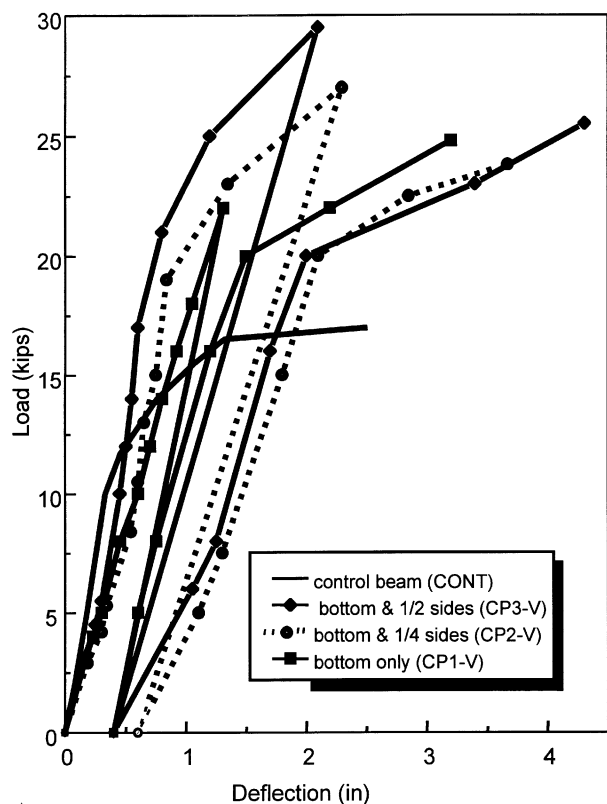
Fig. 6—Response of Group 5 strengthened beams.

Fig. 6 shows the load-deflection relationships for Beams CP1-V, CP2-V, and CP3-V, as well as the control beam. Deflections at a load of 66.7 kN (15 kips) were 22, 19, 14, and 25 mm (0.87, 0.76, 0.57, and 0.98 in.), respectively. Differences in deflections among the three strengthened beams started just above the cracking load, where the CFRP plates are effective in increasing the stiffness of the beams. The high modulus of elasticity of the CFRP plates increased the reinforcing ratio of the beam. In addition, it can be seen that the beam strengthened with CFRP plates on the bottom and on half of its sides (Beam CP3-V) experienced the lowest deflection at the ultimate load, and its ultimate load carrying capacity increased significantly.

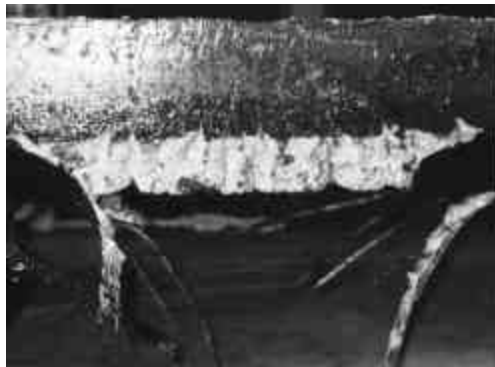
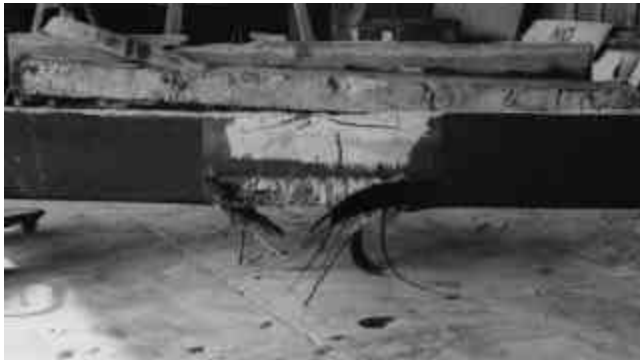
Fig. 8—Failed sections of beams: (a) CF-I; (b) CFS-I; (c) CFS-II; (d) UG1-III; (e) UG2-III; (f) BG1-IV; and (g) BG2-IV.

Fig. 8(a) and (b) show the failed sections of Beams CF-I and CFS-I, respectively. The presence of the vertical layers of CFRP

sheets at the ends of Beam CFS-I limited the propagation of cracks to the unstrengthened area of the beam. Therefore, all the diagonal cracks ended at the intersection of the horizontal and the vertical sheets. Removing the strengthening sheets after failure and inspecting the beams revealed that diagonal cracks did not extend beneath the vertical sheets. However, the diagonal cracks were well-distributed along the span of Beam CF-I and extended

beneath the horizontal sheets. Thereupon, the use of vertical sheets is essential so that the growth of diagonal cracks will be limited.

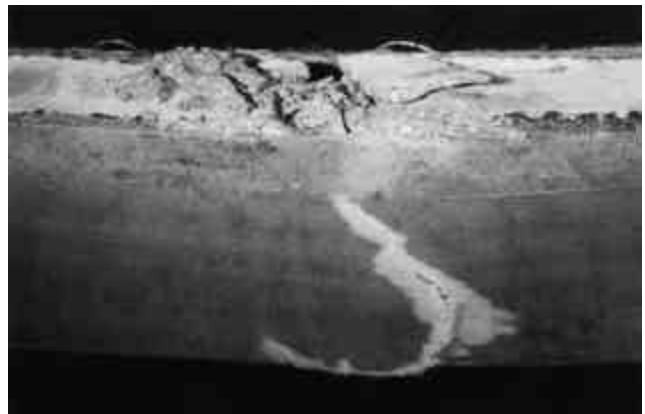
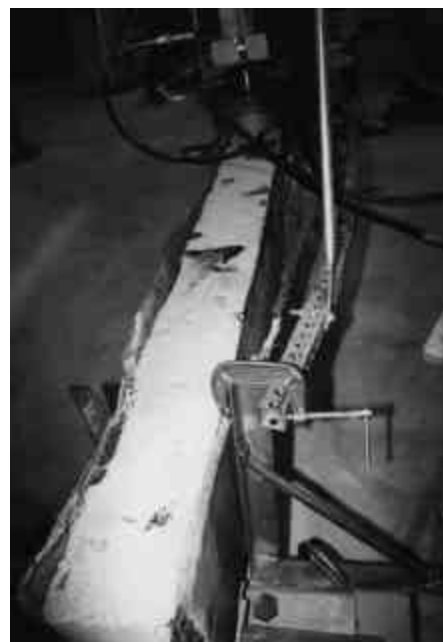
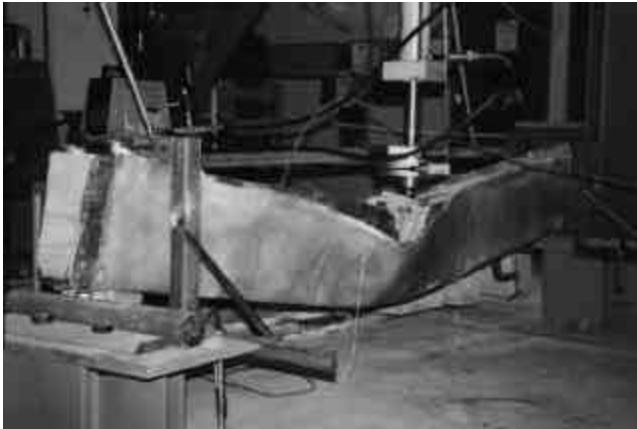
Fig. 8 (cont.)—Failed sections of beams: (h) BG3-IV; (i) BG2-IV-E4; (j) BG2-IV-E1; (k) CP1-V; (l) CP2-V; and (m) CP3-V.

The failed sections of Beams BG1-IV, BG2-IV, and BG3-IV are shown in Fig. 8(f), (g), and (h), respectively. As shown in Fig. 8(c), Beam BG1-IV failed by rupture of the GFRP sheets. However, in Beams BG2-IV and BG3-IV neither the concrete nor the strengthening sheets failed. The failure of Beams BG2-IV and BG3-IV was the result of delamination between the GFRP sheets and concrete, caused by the failure of the bonding epoxy between the concrete and the strengthening sheets. After failure, the strengthening sheets were removed to examine the cracking pat-

tern. One large crack was developed at the midspan of Beam BG1-IV, and the total number of cracks in Beam BG1-IV was less than that of Beams CF-I and CFS-I. This is expected, since Beam BG1-IV was strengthened over the entire depth of the beam, whereas in Beams CF-I and CFS-I, the horizontal CFRP sheets were not applied over the entire depth. Obviously, applying the strengthening material in a U-shape over the depth of the beam is effective in limiting the growth of cracks.
